Dexcom, Inc. | Corporate Headquarters
6340 Sequence Drive | San Diego, CA 92121
888.738.3646 | dexcom.com

Urgent: Medical Device Correction UPDATE
Dexcom G6 Receiver – MT27408-1, Dexcom G7 Receiver – MT26403-0

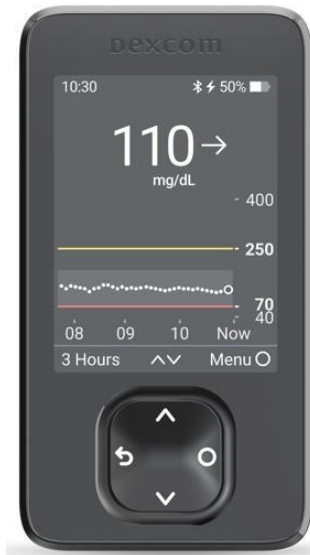
Front of Receiver
Example Rendering:

Image 4: Examples of Affected Receiver

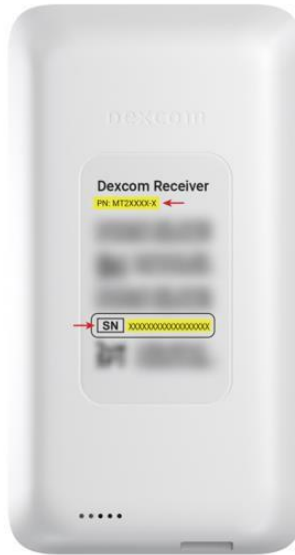
Back of Receiver
Example Rendering:

- Note: The part number and serial number are both listed on the back of the receiver as shown in the image to the right/below):
